MONITORING AND EVALUATION OF RADON MITIGATION SYSTEMS
OVER A TWO-YEAR PERIOD

Richard J. Prill, William J. Fisk, Bradley H. Turk
Indoor Environment Program
Applied Science Division
Lawrence Berkeley Laboratory
University of California
Berkeley, California 94720

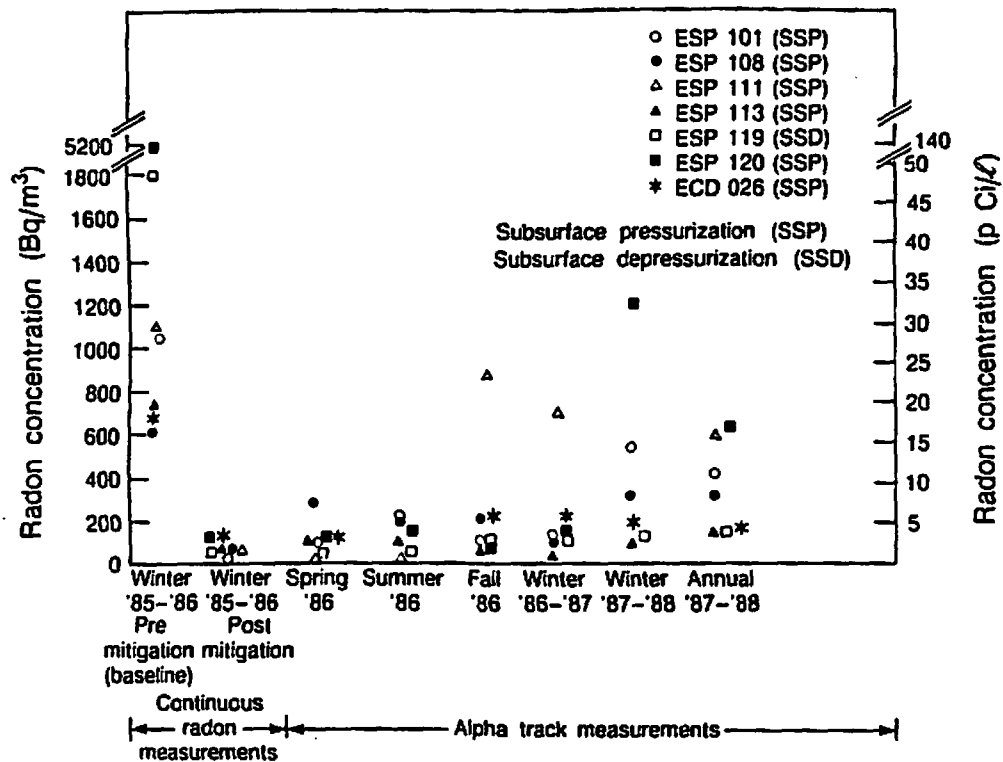
The results from the alpha-track measurements indicate that the SSV systems have maintained radon concentrations significantly below the original baseline, i.e., pre-mitigation, levels (see Table 1 and Figure 1). However, radon concentrations measured during this follow-up study are frequently higher than those reported at the end of the original study and are also occasionally significantly above the EPA guideline of 4.0 pCi/l. All homeowners report that they did not always operate their SSV fans during the late spring, summer, and early fall. In one house with SSP (ECD026), vents in a partial crawl space were closed during the heating seasons.

Figure 1. Radon concentrations in the main occupied level of seven houses with subsurface ventilation systems.

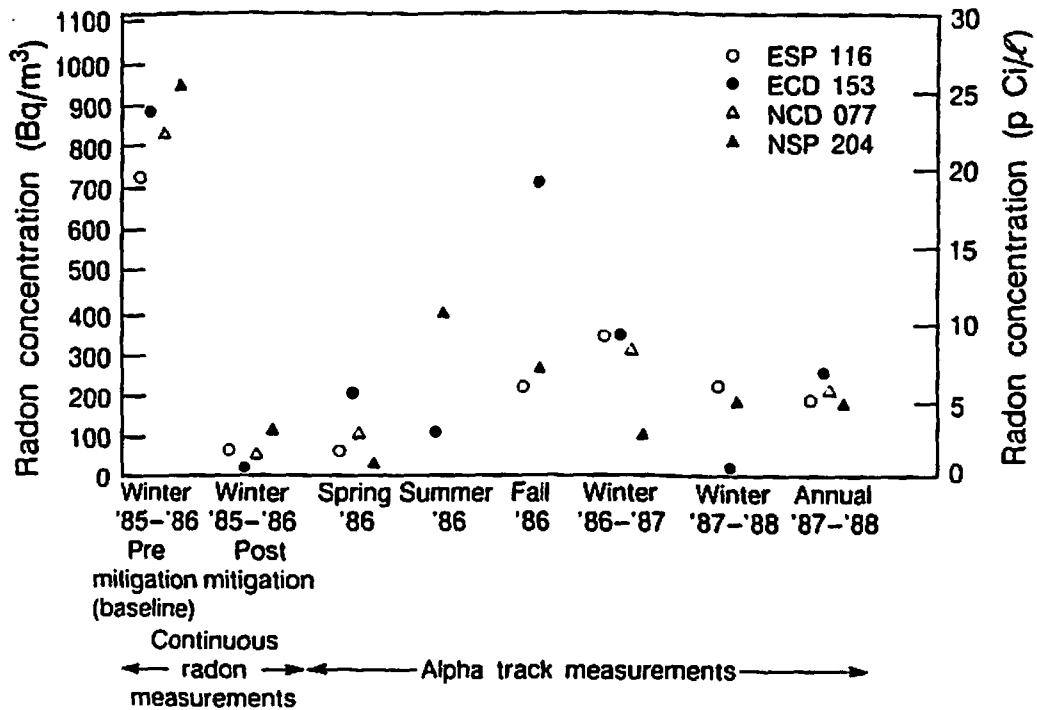
These systems have maintained the main level radon concentrations substantially below the baseline values despite periods when some systems were not operated continuously (see Table 1 and Figure 2). However, the radon concentrations in the basements approached pre-mitigation levels in all of the homes during at least one of the alpha track follow-up measurement periods and many of the measured radon concentrations are above both the original post-mitigation concentrations and the EPA guideline. Some of these increases in radon can be explained. For example, during the winter 1986-1987 the system in house ESP153 was turned off at the discretion of the homeowners, while the system in house NCD077 was not operated because the new occupants had not been appraised of the purpose or operation of the system. Also, the crawl-space vents in these homes were closed during these measurement periods. In all of these houses, increased radon concentrations during the summer may be due to the fact that the systems were not operated and adequate natural ventilation may not have been provided. Some of the fall, spring and even the annual measurements may be skewed since the systems were frequently not operated for the entire measurement period. The increased radon concentrations in houses NSP204 and ESP116 during the winter periods 1986-1987 and 1987-1988 are more difficult to explain since the systems were reportedly operated continuously during the entire measurement periods.

Figure 2. Radon concentrations in the main occupied level of houses with basement pressurization systems.
