RADON REDUCTION SYSTEMS IN SCHOOLS

ABSTRACT

Successful radon reduction techniques applied in houses have been modified and installed in a limited number of schools to reduce elevated radon levels. These mitigation techniques include subslab ventilation and to a lesser extent sealing and pressure control through the heating, ventilating, and air-conditioning (HVAC) systems.

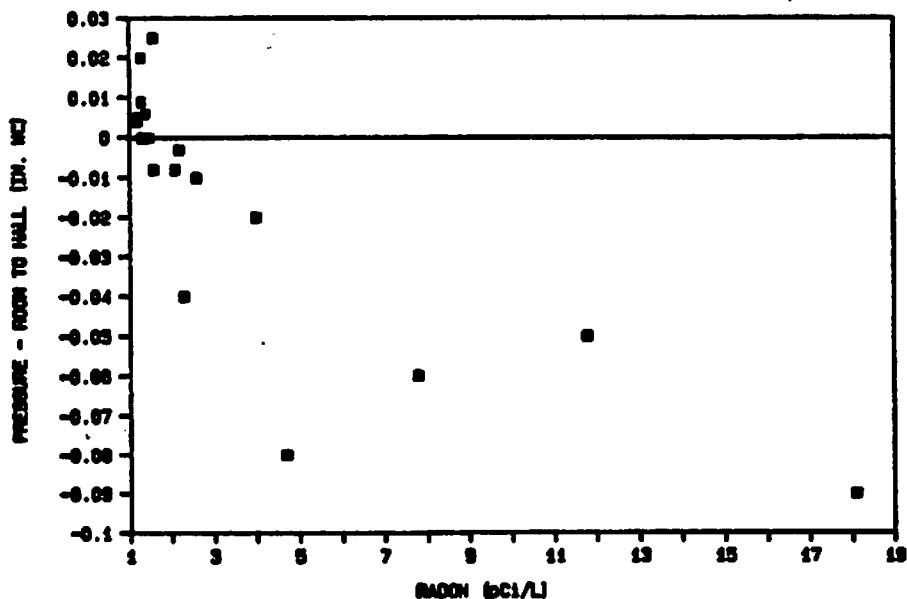
pressure in all rooms if the system were properly balanced. However, continuous radon and pressure measurements with the data logger indicated that many of the rooms were under negative pressure when both the supply and return fans were in operation. The room with the highest radon level measured 15 Pa negative pressure. As seen in Figure 1, there was a good correlation between negative pressure and radon levels in all rooms, with the highest radon levels in the rooms with the most negative pressures. When the return air fan was turned off the pressure in all rooms became positive, and radon levels decreased to less than 2 pCi/L. Examination of the air-handling system showed that the air distribution fan had been damaged and part of the housing cut away resulting in a great loss in capacity. It is believed that the distribution fan was actually supplying less air than the return air fan was removing, resulting in a negative pressure in many rooms.

Figure 1. Correlation Between Radon Levels and Pressure (Case Study A)

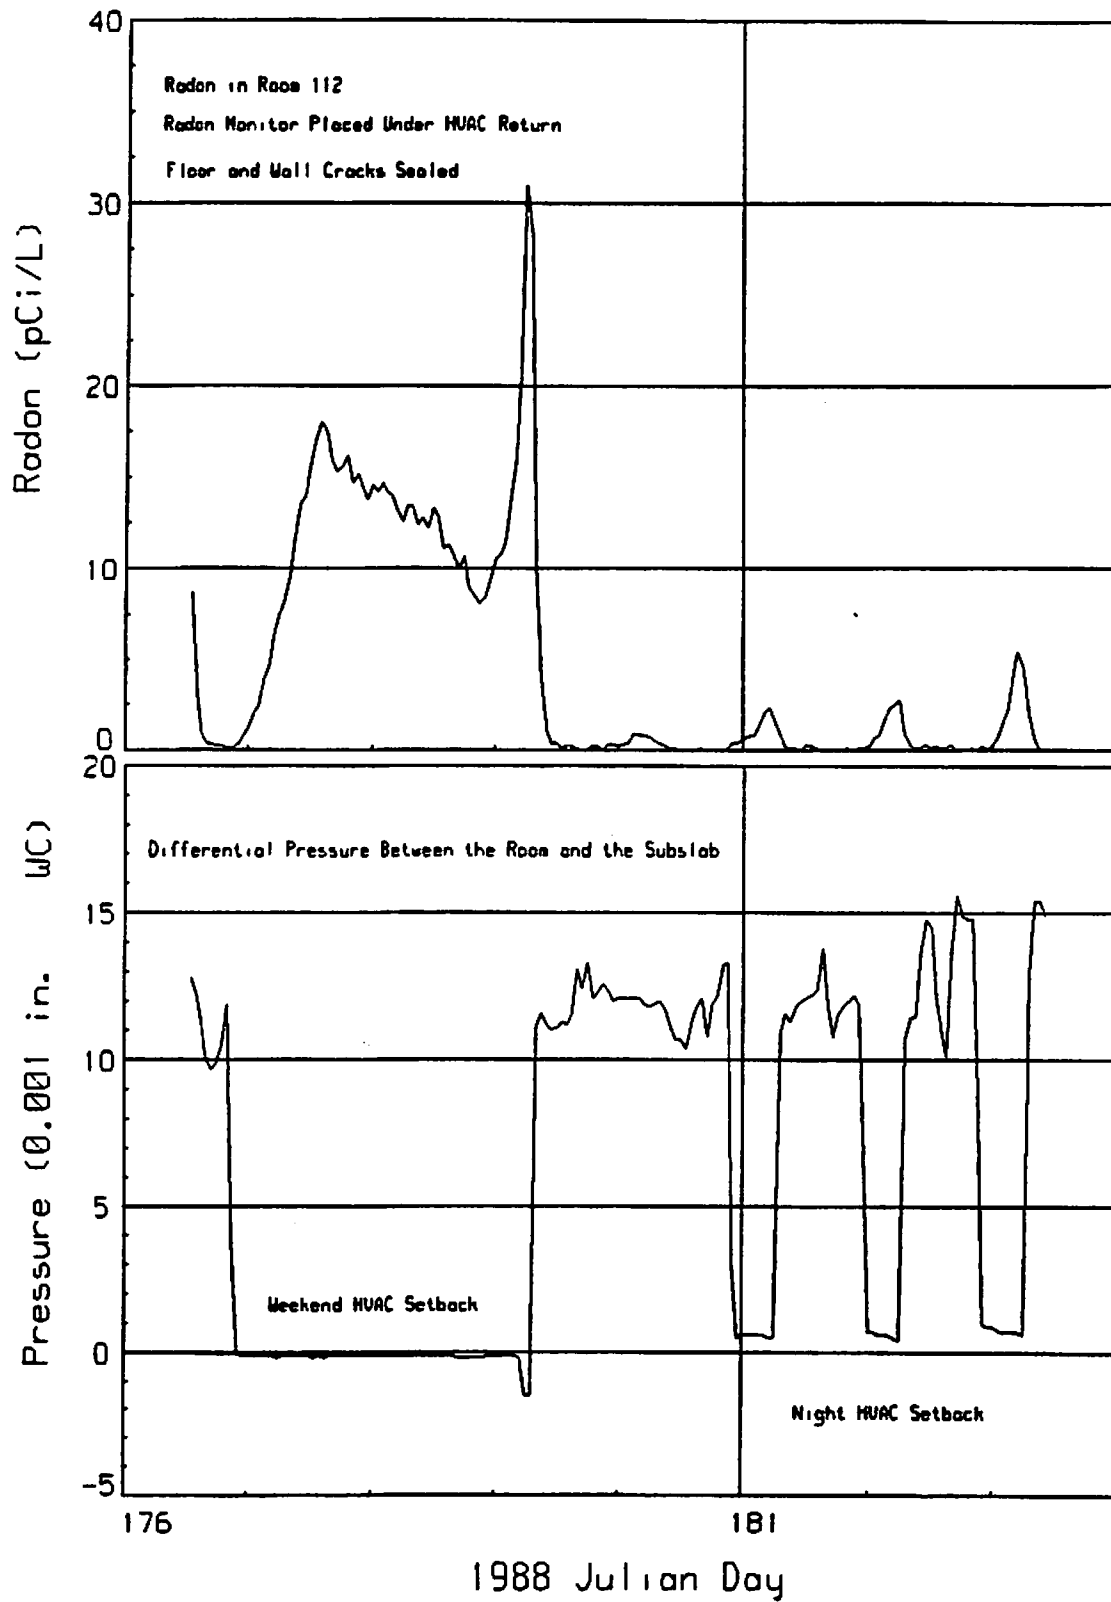
The impact of HVAC operation on radon levels in this room is displayed in Figure 2 for a 7 day period. (The return air louvers were closed during these measurements.) While the HVAC system is operating, the room is at a higher pressure than the subslab area and, consequently, radon entry is reduced. However, when the HVAC system is turned off during night and weekend setback, pressure in the room drops and radon levels increase.

Figure 2. Influence of HVAC Operation on Radon Levels (Case Study A).

As a temporary solution to reduce radon levels, the return air fan was left off and the HVAC system operated with only the air distribution fan. Under these conditions, all rooms showed positive pressure and had radon levels below 2 pCi/L. The damaged supply fan has now been replaced and the air distribution and air return systems are being balanced.

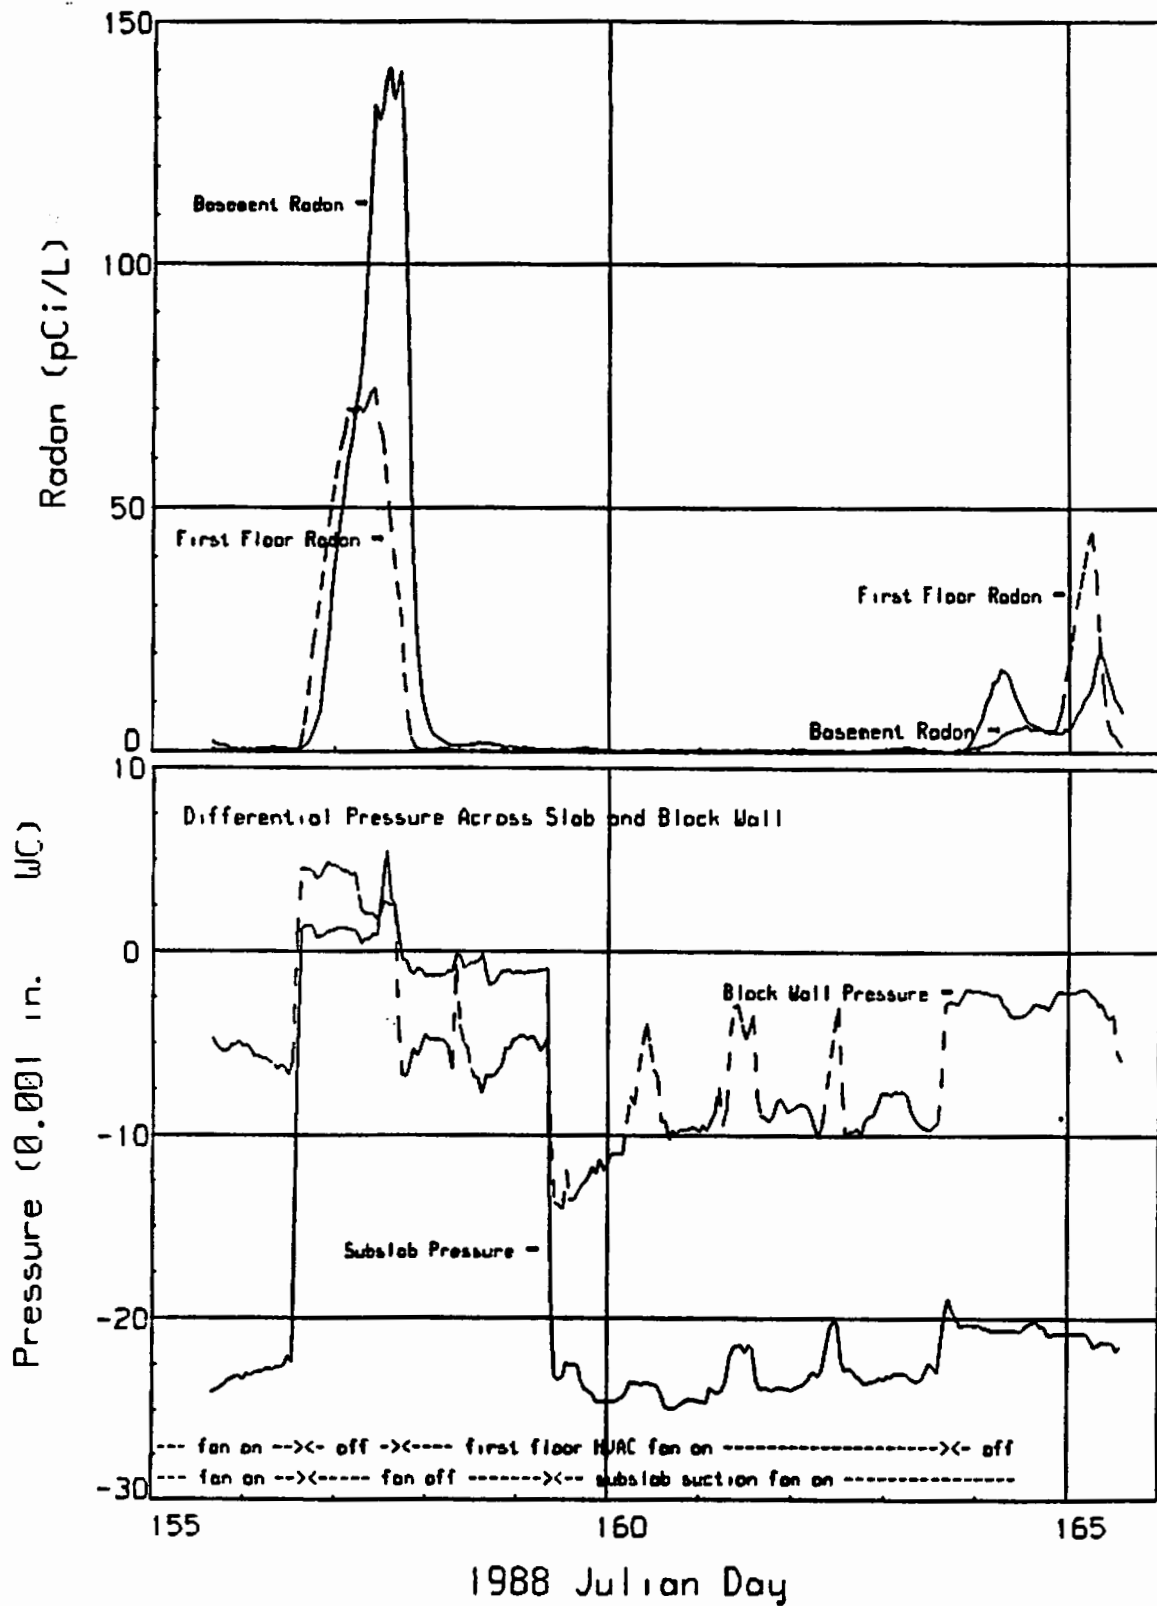
To evaluate the performance of a single-point subslab suction system and to investigate the effects of a single-fan HVAC system on mitigation performance, Figure 3 shows radon and pressure measurements in the school over a 10 day period. The first floor single fan HVAC system was operated continuously during the week to provide mitigation while the school was in session on the first floor. Since the basement was unoccupied during the monitoring period the basement HVAC system was not operated. Over the weekend (day 156), the HVAC system and the single point subslab suction system were turned off, and the radon levels rose quickly on both floors. On day 157 the subslab suction system remained off, but the first floor HVAC system was turned on. Radon levels on both floors dropped, and the differential pressure across the slab and block wall became slightly negative. During the school week (days 158-163), both the HVAC system and subslab suction system were operating, and radon levels remained low. During the following weekend (days 164 and 165), the subslab suction system was operated and the first floor HVAC system was off, resulting in an increase in radon levels. As seen in Figure 3, radon levels on the first floor reached 40 pCi/L under these conditions, so another suction point was installed on the first floor using a Kanaflakt T-3B fan (rated at 310 cfm at 0.75 in. static pressure) and a 3 ft diameter suction hole. The first floor suction point was located on the west end of the building because radon levels were always higher there than on the east end. Subslab radon measurements also showed greater source strength on the west end. Addition of this suction point reduced levels on the first floor although radon levels on both floors still rose above 10 pCi/L at night with the air handlers off.

Figure 3. Influence of HVAC Operation and Single Point Subslab Depressurization on Radon Levels and Pressure (Case Study B).

Pressure field extension measurements indicated incomplete coverage of both floors. Consequently, two additional suction holes were installed in the basement, each with a T-2 fan and a 1 ft diameter suction hole. A 1 ft diameter suction point was also installed on the first floor and manifolded to the existing suction point.

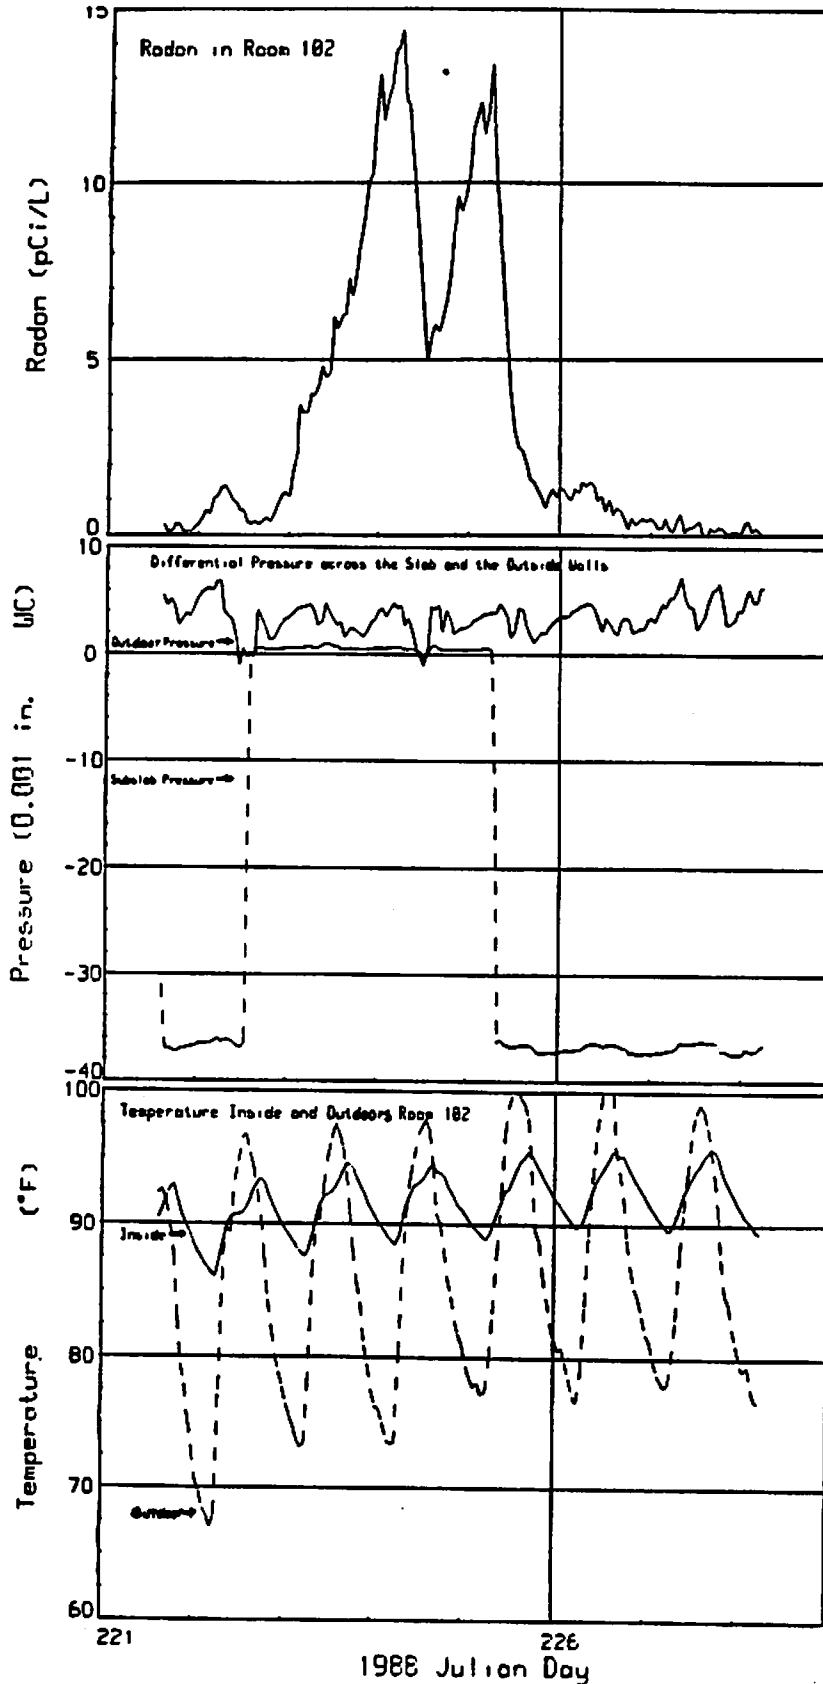
To analyze the effectiveness of a single point subslab suction system and to investigate the pressures that control radon levels in schools during hot weather, radon, pressure, and temperature were monitored continuously in one classroom, as seen in Figure 4. The classrooms were kept closed during this period of very hot weather, and there is no ventilation system in this building. When the subslab ventilation system was turned off from day 222 through day 225, the radon levels quickly rose and followed a diurnal cycle that seems to match the temperature cycle. When the outdoor temperature is coolest relative to indoor temperature, the radon levels are highest. This can be expected from the stack effect, as discussed in Case Study B. Although a small positive pressure was measured across the slab during this period, it does not show significant diurnal variation. The differential pressure across an outside classroom wall does not show much correlation with the radon levels, except for a sharp dip in the middle of day 224 that may be due to wind.

Figure 4. Effect of Single Point Subslab Depressurization on Radon Levels (Case Study D).
