COMPLEX RADON MITIGATION OF A LARGE BUILDING

David Wilson, Oak Ridge National Laboratory, Oak Ridge, Tennessee, USA

Stanley Ng, Pacific Division, Naval Facilities Engineering Command, Pearl Harbor, Hawaii, USA

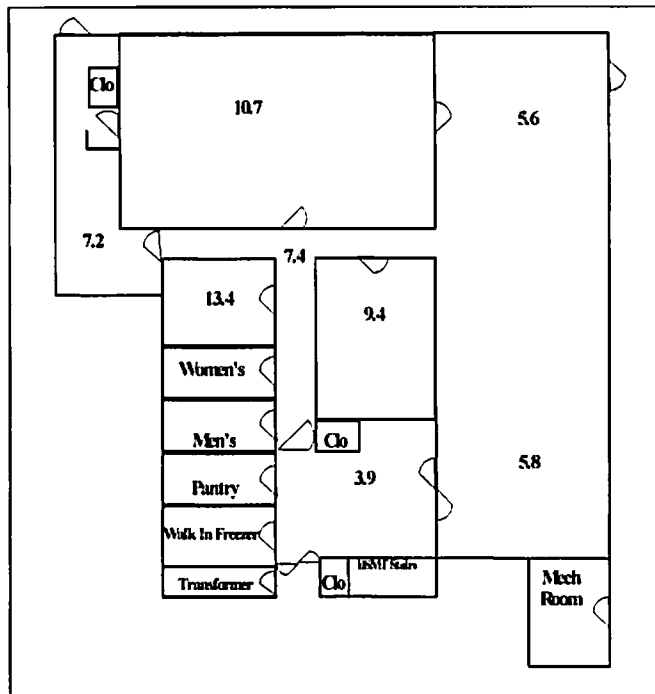
Figure 2. Long-term radon results in pCi/L

During 1997 to 1998, long-term radon testing using alpha-track detectors was performed within all routinely occupied rooms. Of the seven rooms tested, six were determined to have elevated radon levels, ranging from 5.6 pCi/L to 13.4 pCi/L (Figure 2). In 1999, short-term follow-up testing (electret) was repeated in the seven rooms, the basement, and both bathrooms. These

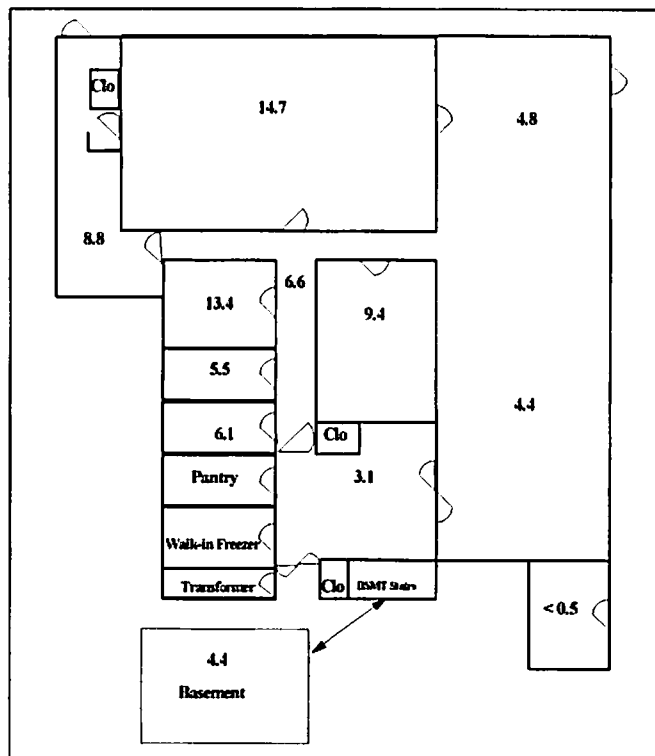
Figure 3. Short-term radon results in pCi/L

follow-up tests confirmed the original long-term test data and identified three additional rooms for radon mitigation (Figure 3).

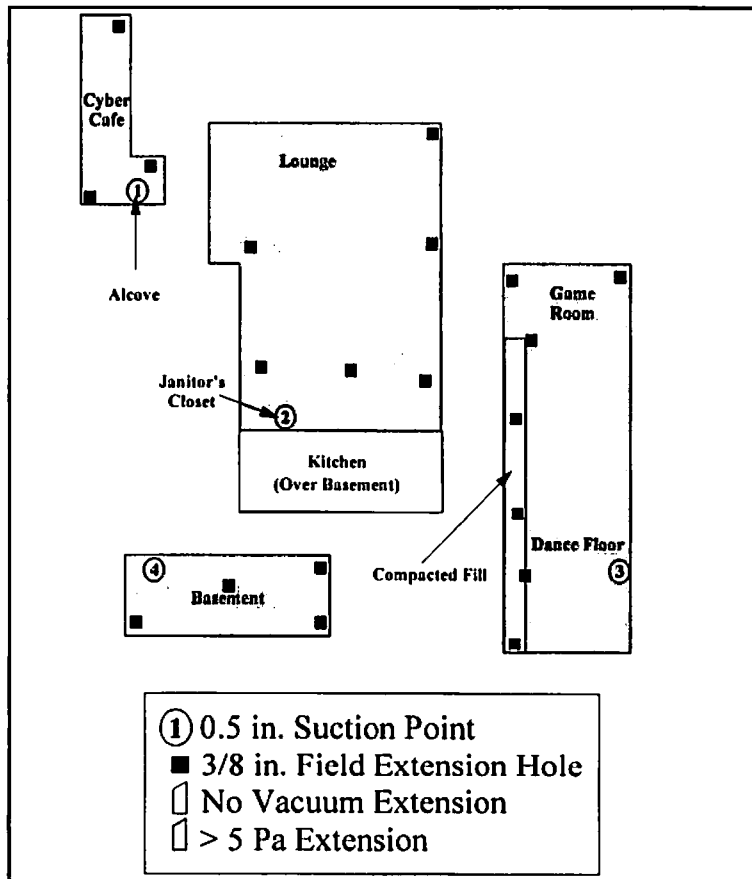
Figure 5. Subslab field extension

Because of the renovation history of the building, subslab diagnostics were performed on each of the three slab-on-grade subslabs and the basement slab to determine if active soil depressurization (ASD) was feasible (Figure 5). Field extension data collected with the air conditioning turned on and no exhaust systems operating [(-) 5 Pa] determined that a three-fan, three-suction point system (Figures 6, 7, 8, and 9) would cover 100% of the slab-on-grade subslabs. The diagnostics were then repeated at (-) 14 Pa (all exhaust systems except the grill), and the coverage dropped to about 60%. Coverage with all exhausts systems turned on [(-) 80 Pa] dropped subslab coverage to an average of <5%. With the marginal coverage at (-) 14 Pa for the slab-on-grade subslabs, it was estimated that three additional suction points would be needed. Two of these additional penetrations would be located on the exterior of the building and would not cause a problem. However, because of the usage of space and the mostly open floor plan, one of the suction points would need to be near the middle of the dance floor. Therefore, this option was discounted as well.

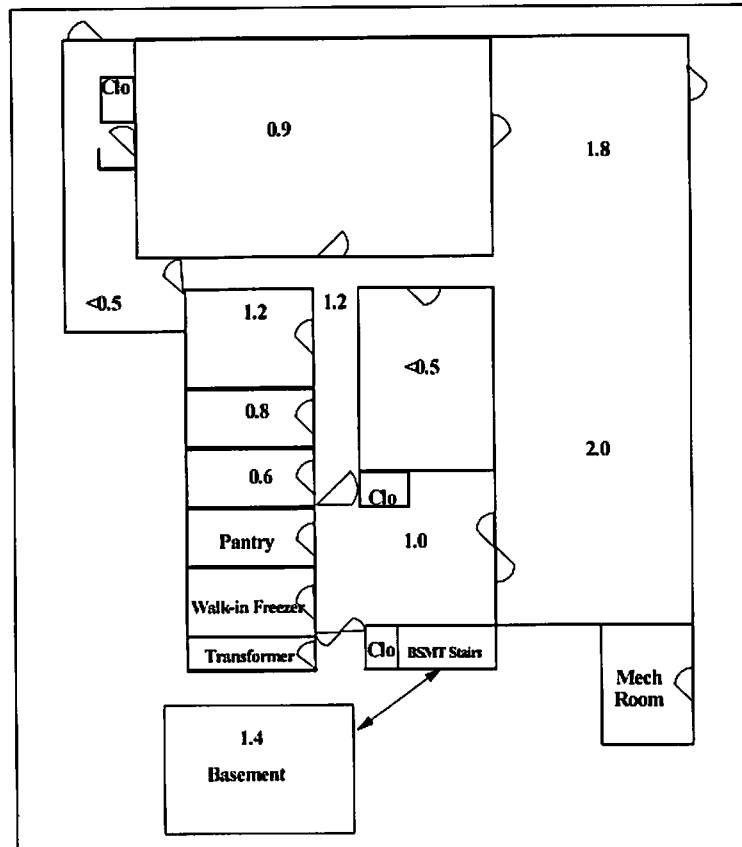
Figure 13. Postmitigation results in pCi/L

Postmitigation testing of the building with the passive kitchen louvers open, all three ASD systems operational, and the 5-ton supplemental makeup air system (800 CFM) operational found that radon levels within the building had dropped significantly (Figure 13). As an added benefit, the changes made to the building (e.g., passive louvers and the added cooling) significantly improved the overall comfort factor of the building. For one, these improvements eliminated the need to preload cool the building prior to opening. Second, condensation problems within various rooms of the building were eliminated. Third, for the first time, the two preexisting mechanical systems in the building actually achieved the desired thermostat setting and cycled off, meaning potentially lower energy and maintenance costs.
