WELL VENTS, A SIGNIFICANT SOURCE OF INDOOR RADON: A CASE STUDY

William J. Bell
Massachusetts Department of Public Health
23 Service Center
Northampton, MA 01060

Zygmunt F. Dembek
Radon Program
Connecticut Department of Health Services
150 Washington Street
Hartford, CT 06106

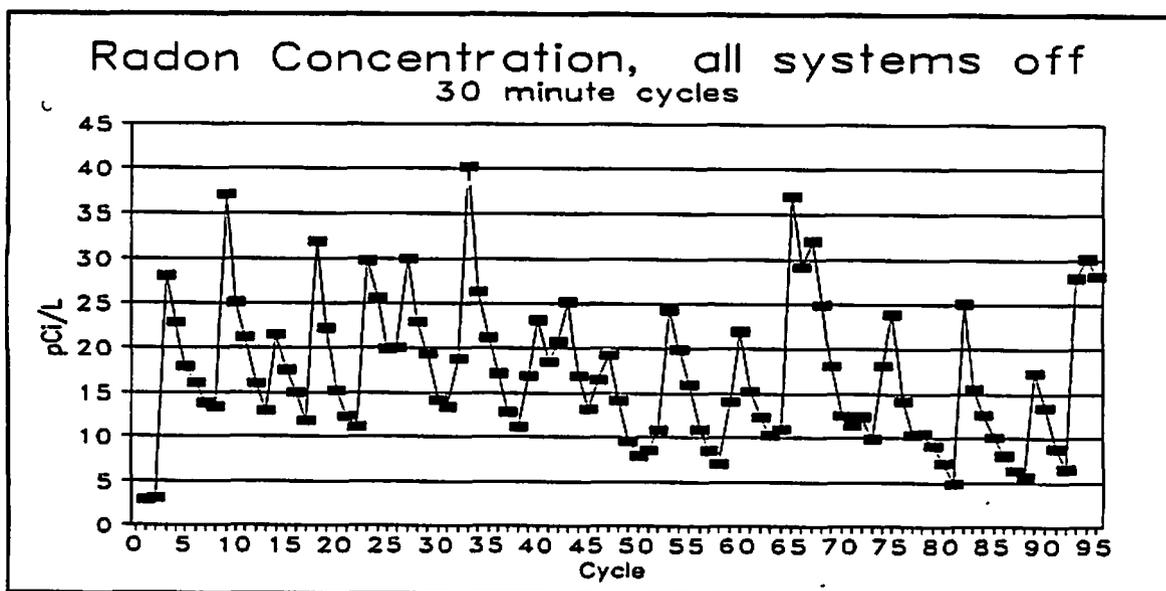
Figure 1. Radon Levels with Both SSD/BWD Systems Inoperative, 30 Minute Cycles

The above information implied that the cause of the exacerbated radon in air levels was located in the work room area. Therefore, two Pylon® AB-5 continuous radon monitors were utilized to study radon fluctuations in this area. One of the monitors was set up upon a work bench about 1.3 m high and the second was set up on a dehumidifier (non-operating) about 0.8 m high. It was decided to observe radon levels in this area with both SSD/BWD systems operating, only one (of each of the) SSD/BWD systems functioning, and with both of the systems turned off. Figures 1, 2 and 3 represent readings taken from the workbench site under different mitigation conditions.

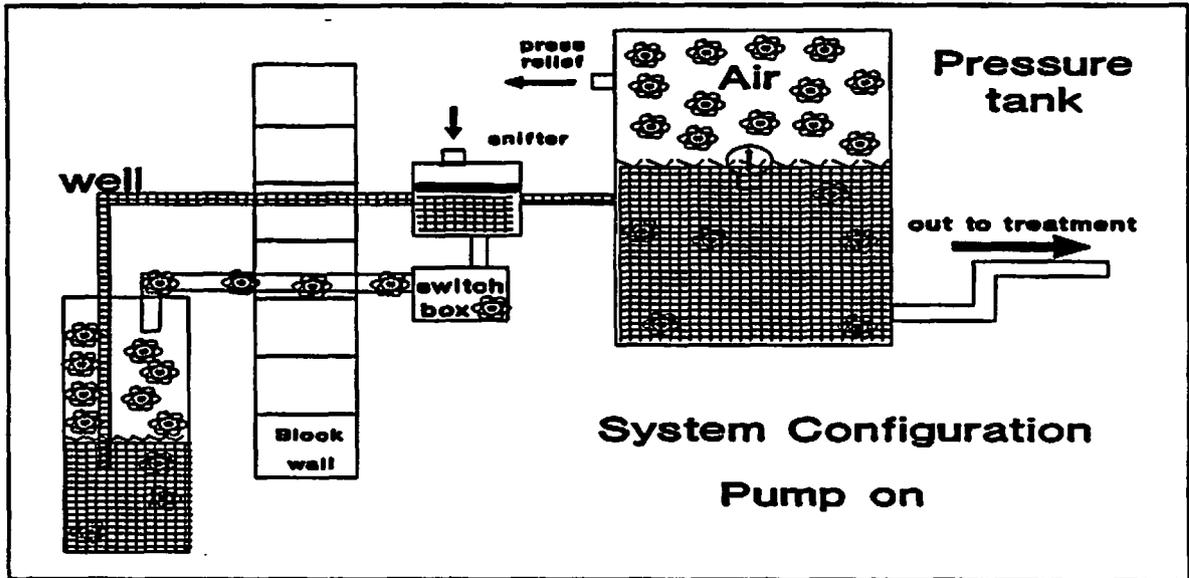
Figure 4 Pump Operating

The following two diagrams of the water pump system show the valve and vent positions with the pump operating (Figure 4) and not operating (Figure 5).

Upon cessation of pumping, a sniffer valve, located near the switch box, allows basement air to enter the well water supply line acting like a vacuum breaker. Water in the line is replaced by house air back to the water level in the well. When pumping resumes, the air which now contains substantial quantities of radon gas is pumped into the pressurized storage tank. Ultimately, that radon laden air is purged from the tank to the indoor air via the pressure relief valve on the pressure tank.

In an effort by the contractor to correct the situation the relief valve on the tank air was removed so that it did not off-gas into the basement area. Subsequently, a Pylon® AB-5 radiation monitor was set in the vicinity of the pressurized water tank to continuously record radon concentrations. The intermittent peaks characteristic of brief introduction of high concentrations of radon gas continued.
