COMPLEX RADON MITIGATION OF A LARGE BUILDING

David Wilson, Oak Ridge National Laboratory, Oak Ridge, Tennessee, USA

Stanley Ng, Pacific Division, Naval Facilities Engineering Command, Pearl Harbor, Hawaii, USA

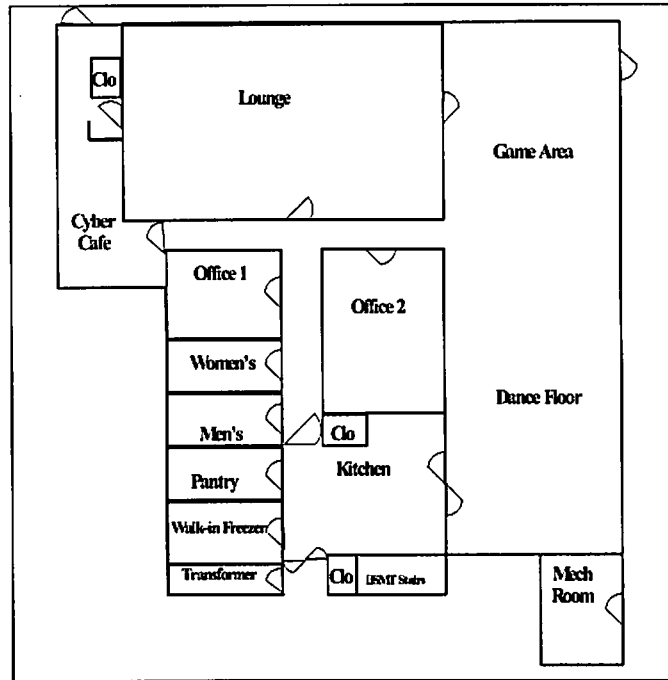
Figure 1. Home Plate floor plan

Relative to the outdoors and with all exhaust systems turned off, the game room (Figure 1) shell differential pressure (DP) was (-) 5 Pa and 0 Pa if both air conditioning mechanical systems were turned off as well. This 5-Pa loss of conditioned air was linked to leaks in the external ductwork of System 1 and the transition collar at the unit supply duct interface. Sealing around the transition collar was feasible. However because the supply duct was covered with a riveted, insulated metal wrap, finding the duct joints that were leaking would have required replacement of the entire duct. During normal mechanical operation, little variation in DP (± 2 Pa) was found in the lounge or in offices relative to the open areas of the building. This was an indication that the forced air systems were balanced. Overall, the ducting design for both air conditioning systems was found to be adequate, and both systems were found to be reasonably well balanced and maintained. The only problem noted was the absence in the design for any fresh-air makeup.

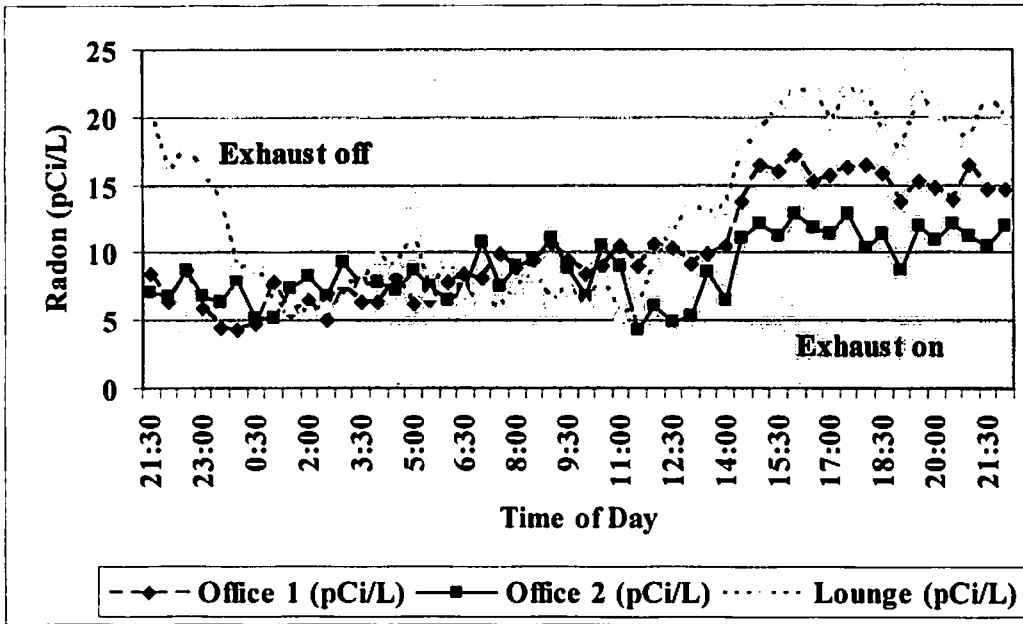
Figure 4. Continuous radon levels in three rooms as a function of exhaust

Assuming that the makeup air problem in the kitchen could be solved, diagnostics were then directed toward the two forced-air mechanical systems to determine if they could condition sufficient makeup air to equalize the pressure imbalance, pressurize the shell, or increase the building’s air change significantly. To determine if vacuum reduction was an option, continuous radon measurements (CRM) using a FemtoTech Model 210F radon detector were performed in three rooms with all mechanical exhaust systems turned off. Although the radon levels were significantly lower at (-) 5 Pa, all three rooms were still >4 pCi/L (Figure 4). Shorter duration tests with the mechanical exhaust turned off, as well as with the two forced-air mechanical systems turned on (0 Pa), did not show any additional decrease in radon levels.

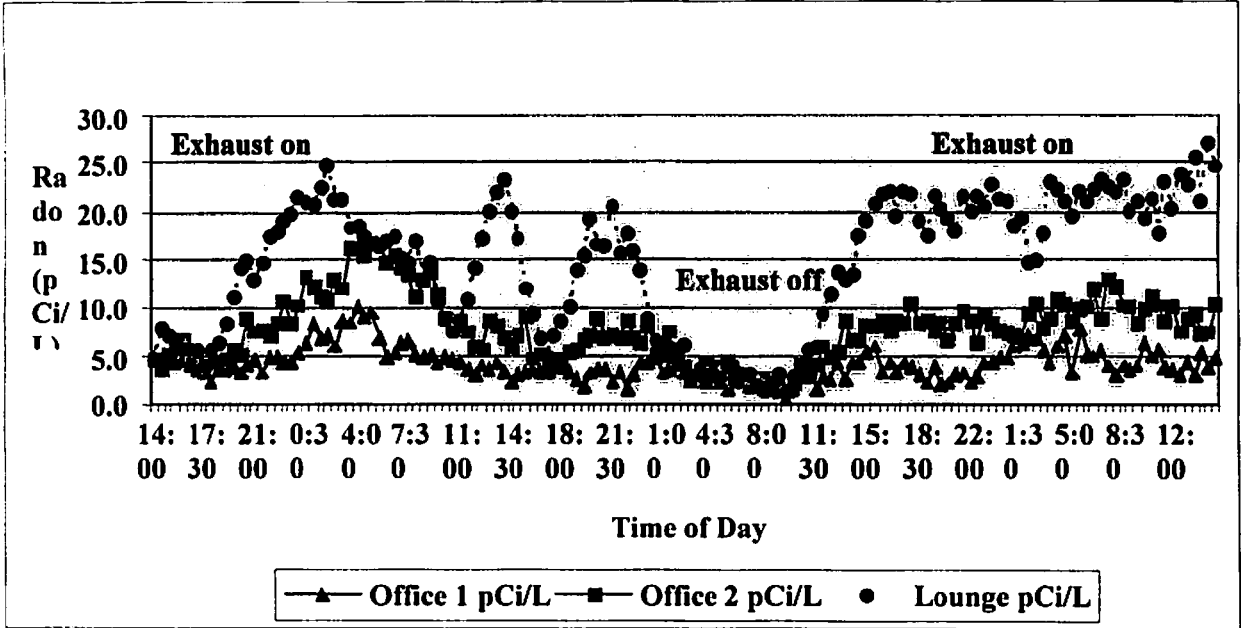
Figure 10. Radon levels in three rooms before supplemental air

The three-fan (GP 501), four-suction-point ASD system was installed as originally proposed (Figure 6). As predicted by the subslab diagnostics, at (-) 14 Pa, with all exhausts turned on except for the grill, only 60% of the subslabs were covered. Postmitigation testing found that only conditions in the Cyber Café were mitigated. CRM measurements performed in three rooms identified as having elevated radon levels showed that room conditions were mitigated if the exhaust systems were turned off (Figure 10). Additional subslab diagnostics determined that mitigation could be achieved if the shell pressure could be reduced to (-) 8 Pa or less. After consulting the blower door curves generated during earlier diagnostics, it was estimated that only 800 CFM of additional fresh air would be needed to achieve this pressure.
