## WASHINGTON STATE PASSIVE STACK STUDY

Jan E. Fay and Ray Tekverk  
Faytek Incorporated  
Coeur d'Alene, ID

### **ABSTRACT**

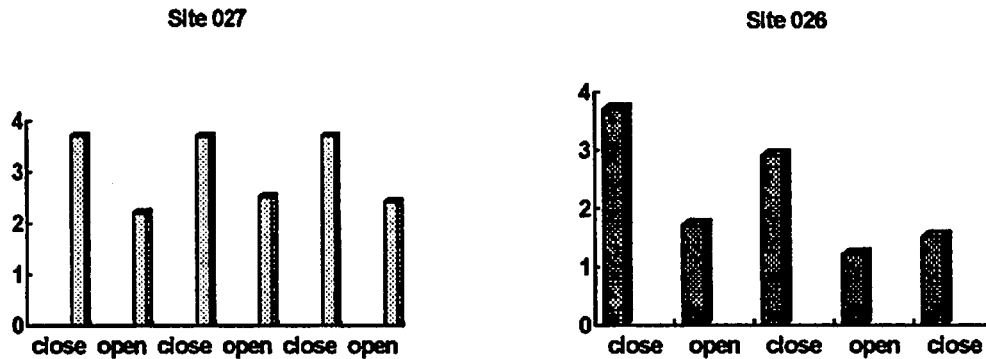
Below are two examples of houses where the variations in radon levels under alternating stack conditions appear to be significant. Radon levels are graphed in picoCuries/Liter, and the stack condition (opened or closed) is noted on each measurement.

While lower radon levels under open stack conditions were observed in quite a few of the early test houses, in many of the cases the fluctuations were either so small that they are not conclusive, or the number of test rounds to date is small enough that statements on performance would be premature.

It is interesting to note, that these houses in the first round of testing were in a subset of houses where the material under the slab is a very tight and compactable unwashed pea gravel rather than the coarse "radon rock" of the Spokane houses. As a preliminary observation, this suggests that radon level reduction through the use of a passive stack may not require particularly good communication under the slab. In fact, the pressure field extension tests in the Post Falls houses indicated very poor pressure field extension in the sub slab environment.
